Detour Route for the Damaged Index-Galena Road

Current Conditions on the Ground

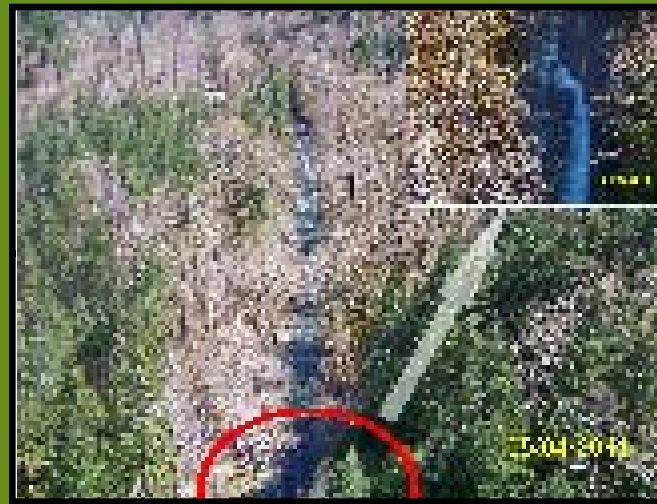
Photo 01
This photo shows a portion of the existing road corridor from Milepost 6.4. Looking up valley, the new side channel still flows down the existing road corridor. The inset details the spot at which the water returns back towards the river.

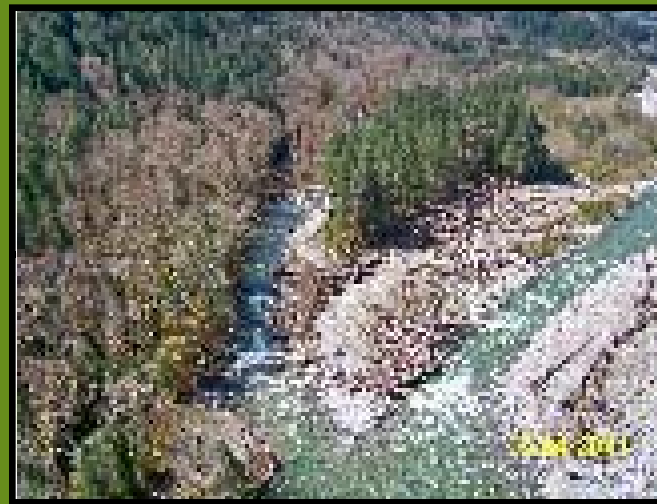
Photo 02
This photo looks downstream from the upper end of the new side channel. Of particular note is the volume of water found in the new side channel.

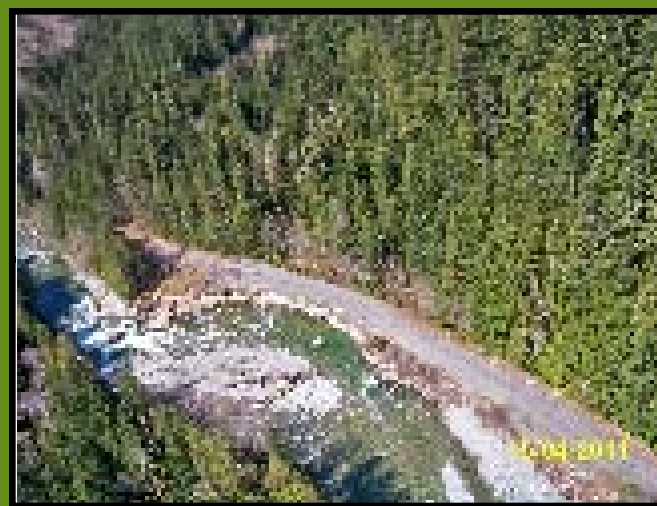
Photo 03
Looking downstream, this photo shows the damage located approximately at Milepost 10.9.

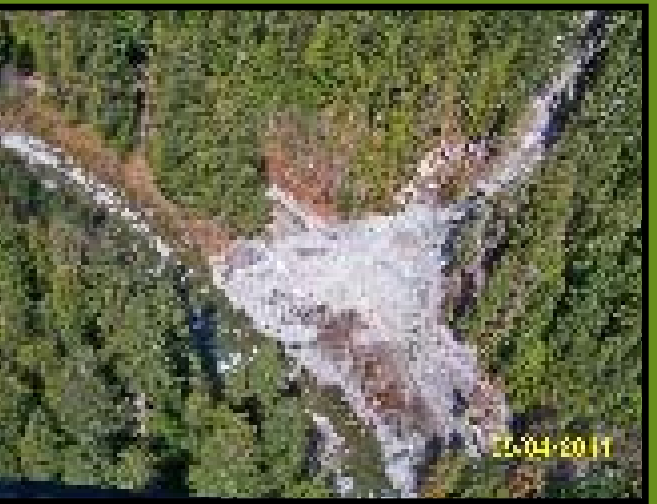
Photo 04
Located approximately at Milepost 13, this gully on Troublesome Mountain frequently deposits a large amount of rock debris onto the road, hindering access to the upper valley.

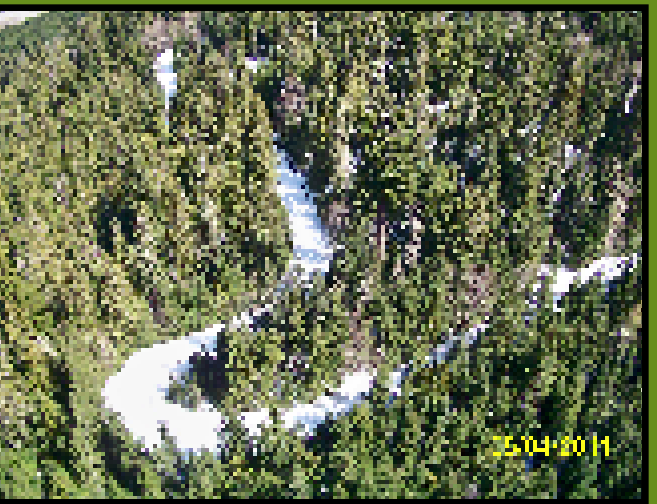
Photo 05
This photo shows the steep switchbacks below Jack's Pass located on the north side of the pass. Without the assistance of snow removal during winter, negotiating the road is quite hazardous.

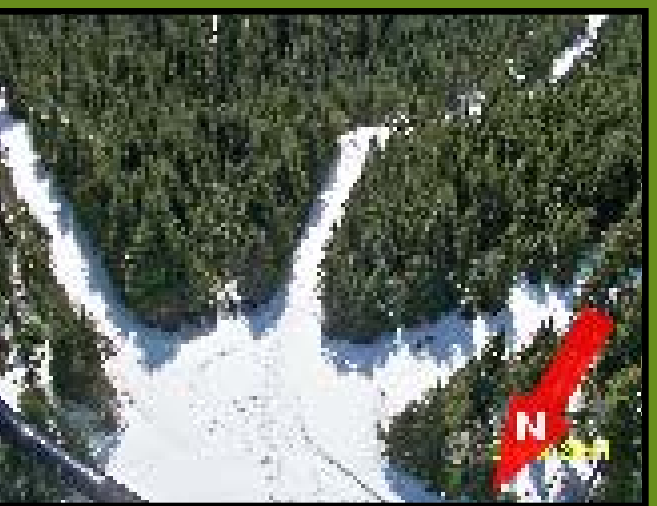
Photo 06
This photo looks southeast, from above Jack's Pass. Despite a modest elevation of 2,500 feet, winter snowfall prevents year-round access of the North Fork Skykomish River valley.
